Water Usage at an Oil Refinery

An oil refinery in Wales contacted RS Hydro to see if it was possible to monitor water usage across the refinery on a temporary basis to try and determine where 100m³ was being lost.

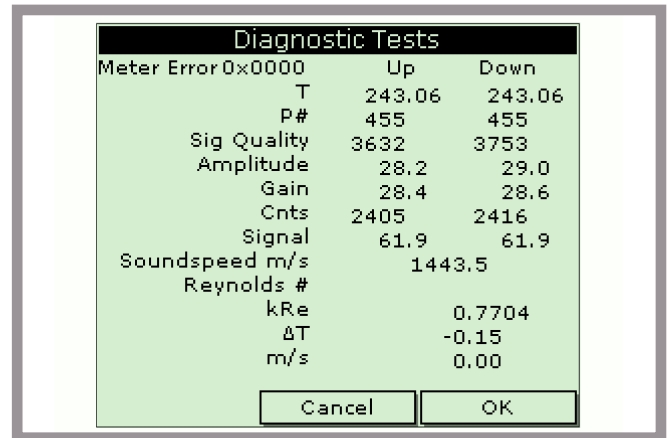
fig2. A diagnostic test page

Diagnostic Tests		
Meter Error 0x0000	Up	Down
T	243.06	243.06
P#	455	455
Sig Quality	3632	3753
Amplitude	28.2	29.0
Gain	28.4	28.6
Cnts	2405	2416
Signal	61.9	61.9
Soundspeed m/s	1443.5	
Reynolds #		
kRe	0.7704	
ΔT	-0.15	
m/s	0.00

Following each meters installation, diagnostic test result screen dumps were taken to prove that the meter was running between certain limits when left by the engineer.

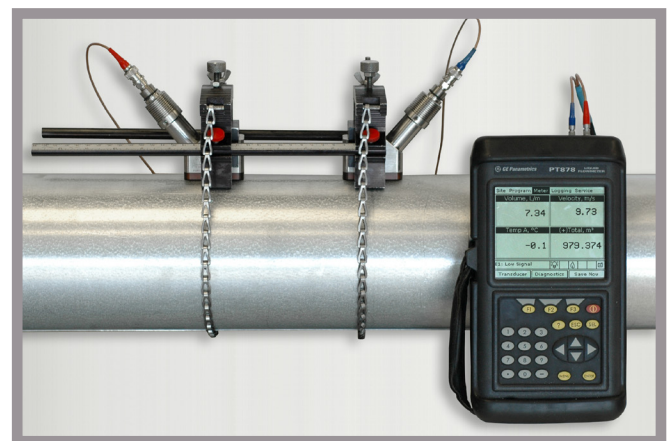
fig3. The Panametrics PT878 Ultrasonic Flow Meter.

There were twelve different locations where water usage needed to be monitored. It was decided that the Panametrics PT878 ultrasonic clamp on flow meter would be installed at the locations to provide the temporary monitoring. The meters were all installed within one and a half days, without the need for any pipe modifications.

As the Panametrics PT878 has a typical battery life of 8 to 11 hours, this was not sufficient for the three day monitoring period. Normally this would be solved by running the unit off mains power but this was not a possibility at the refinery. Instead, the PT878s were connected to car batteries which provided continuous power for the three days.

Site conditions including noise and pipe materials caused ringing in the pipes which would sometimes cause ultrasonics to struggle. This was not the case with the PT878 and single traverse installations made the measurements possible. The meters were each set up to record flow rates and total flows over the three days.
